# Manhole Inspection Summary

Manhole # S07CC2013MH

Insp Date: **7/26/06 10:31 AM**

**Location** Address: **6003 STUART AVE**

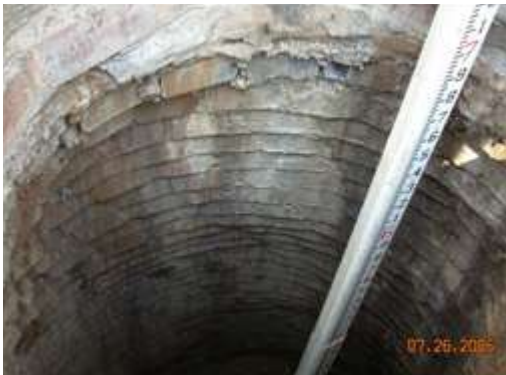
Defect

Infiltration: ☐ None ☒ **Joint** ☐ Cracks ☒ **Mortar** ☐ Roots ☐ Wall

Infiltration: ☐ None ☐ Joint ☐ Cracks ☒ **Mortar** ☐ Roots ☒ **Wall**

Adjustment and Corbel loose brick.  
Adjustment and Corbel infiltration.

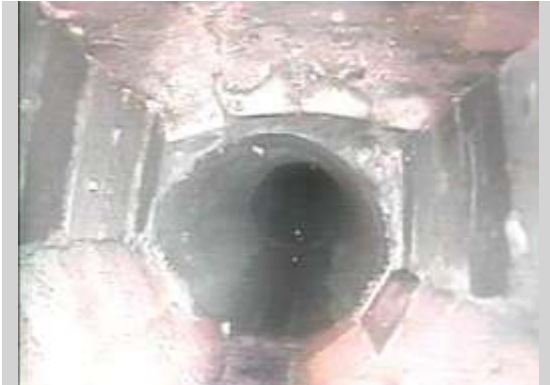
### 8 in. Circular Gravity Sewer Pipe Out @ 12 O'Clock

Infiltration: **Evidence** Pipe Seal Cond: **Unknown**

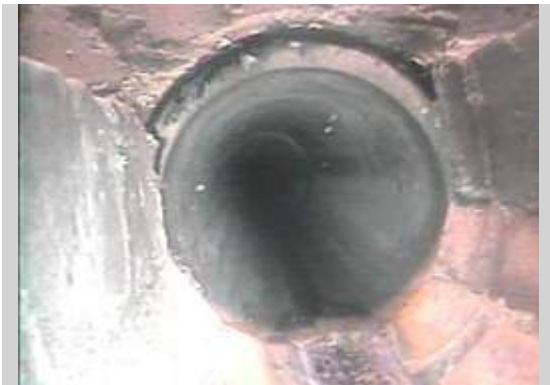
### 8 in. Circular Gravity Sewer Pipe In @ 5 O'Clock

Infiltration: **Evidence** Pipe Seal Cond: **Unknown**
